Manhole Inspection Summary

Manhole # S09YY_008MH

Location Address: **3604 GRANTLEY RD**

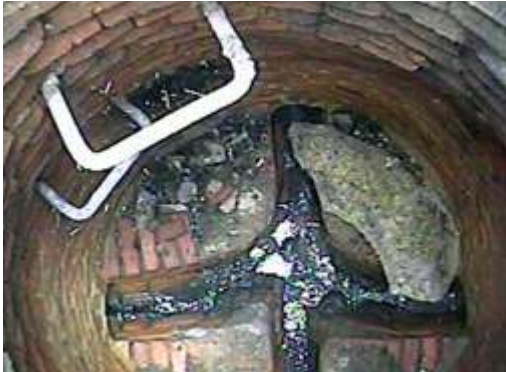
Defect 1

Condition: ☐ Sound ☐ Cracked ☐ Root Intrusion ☐ Deteriorated ☐ Leaks ☒ **Debris**

DEBRIS

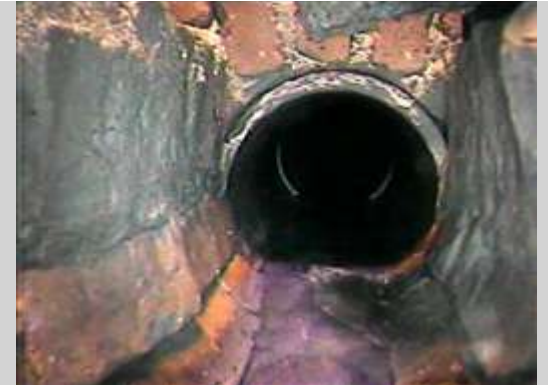
12 O'Clock Outflow

8 in. Circular Gravity Sewer
Pipe Out @ 12 O'Clock

Infiltration: **None** Pipe Seal Cond: **Cracked**

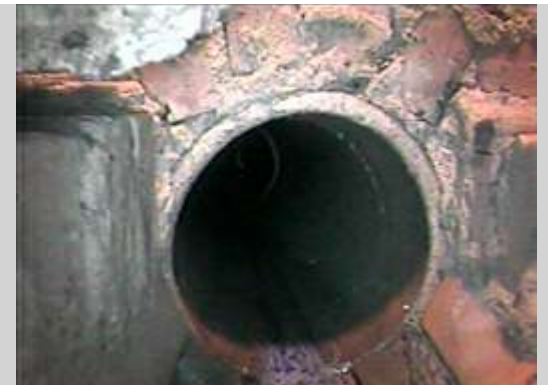
3 O'Clock Inflow

8 in. Circular Gravity Sewer
Pipe In @ 3 O'Clock

Infiltration: **None** Pipe Seal Cond: **Sound**

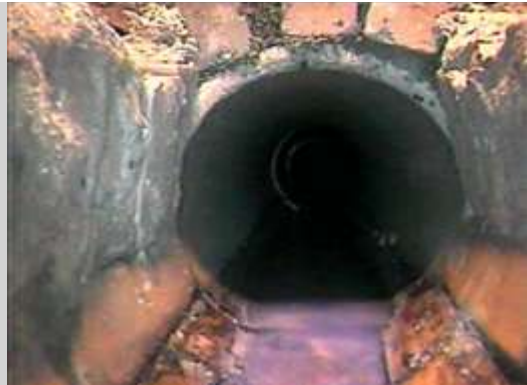
6 O'Clock Inflow

Infiltration: **None** Pipe Seal Cond: **Sound**

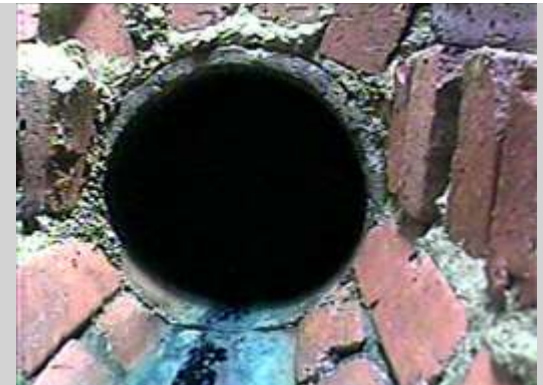
9 O'Clock Inflow

Pipe In @ 9 O'Clock

Infiltration: **None** Pipe Seal Cond: **Cracked**
